Inspection Report

Mine Name: Cane Creek
Operator Name: Intrepid Potash

Permit number: M0190005
Inspection Date: September 25,
2007
Time: 8:00 to 11:00 AM

M0190005, Cane Creek Mine, Intrepid Potash

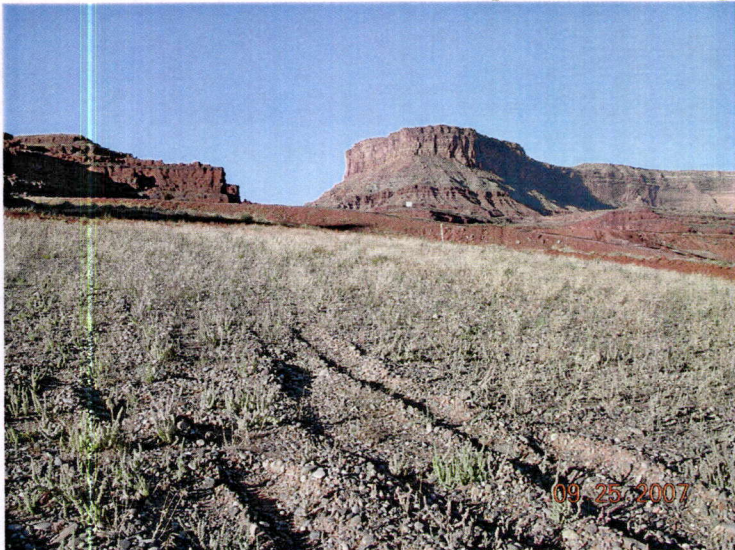
1. Control plot (Photo 1). This is near the salt tailings pond, but the soil has not been affected by salt. An alluvial gravel soil was placed over the native soil, and the dominant vegetation is cheatgrass and halogeton with some Russian thistle, galleta, globemallow, blue grama, sand dropseed, and purple three-awn.

It is possible the soil used for the control plot had a large bank of cheatgrass seeds and that this is why so much cheatgrass is growing in this plot. I wondered if this material came from the surface of a borrow area and if material from lower in the profile was used for the plots at the salt tailings pond where there was less cheatgrass.

Photo 1. The control plot. Most of the plants are cheatgrass and halogeton.

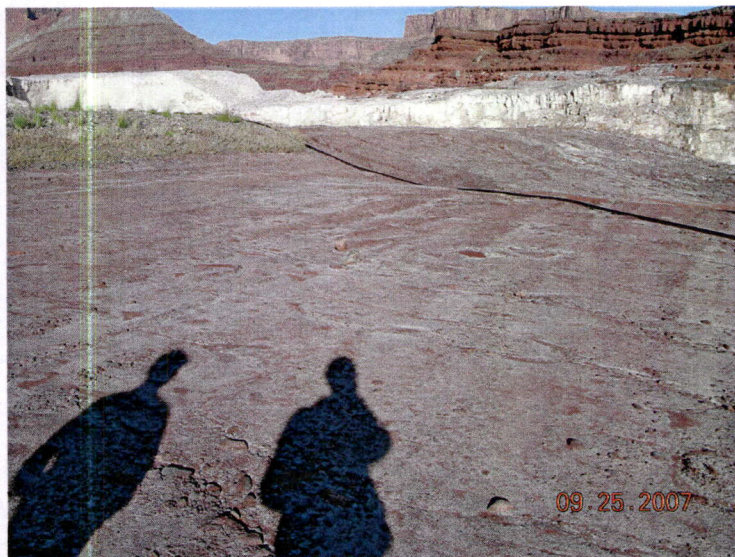
2. Salt tailings pond plots. There are four plots, one of which has not yet been planted. One has three feet of alluvial gravel soil, one has two feet of this soil, one was irrigated for a year to leach the salts and was then seeded, and the other is being leached and should be seeded this fall. The plot that was leached then planted (Photo 2) has no vegetation and has some salt on the surface. The plots with three and two feet of soil (Photos 3 and 4) have a fair amount of desirable vegetation, but they also have some weeds. Desirable plants growing on these plots include purple three-awn, sand dropseed, blue grama, galleta, scarlet globemallow, and an unidentified grass (Photo 5). (It would be good to identify this grass since it was fairly common.) There

Photo 2. This plot in the salt tailings pond area was irrigated for one year then seeded.

At this time, it does not appear that leaching salts from the salt tailings pond soils has been effective. I would like to reserve final judgment until I have seen the results from the plot that has been irrigated for two years. When the plot irrigated for two years is planted, I suggest that it be left as rough as possible, possibly furrowed. The furrowed plot showed some success in concentrating salts on the furrow peaks.

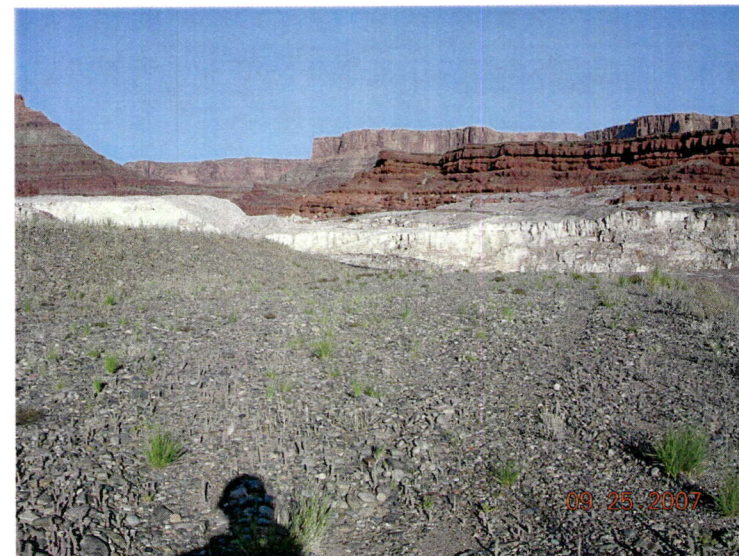
were also weeds, but not nearly as many as in the control plot. The plot with three feet of borrow material had more desirable vegetation than the plot with two feet, but the difference is probably not significant. I was impressed with the number of warm-season grasses in these areas: warm-season grasses are often difficult to establish in reclaimed areas.

Photo 4. Similar to the plot shown in Photo 3, but only two feet of growth medium was used.

It is too early to judge whether there is a difference between two feet and three feet of borrow material over salt-affected soils. Vegetation cover should be measured and compared after another year or two.

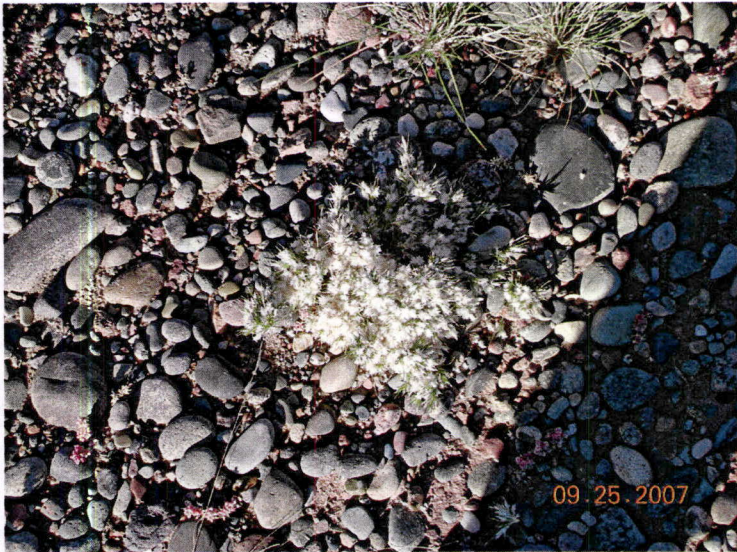
Photo 5. An unidentified grass in the plots with borrow material.

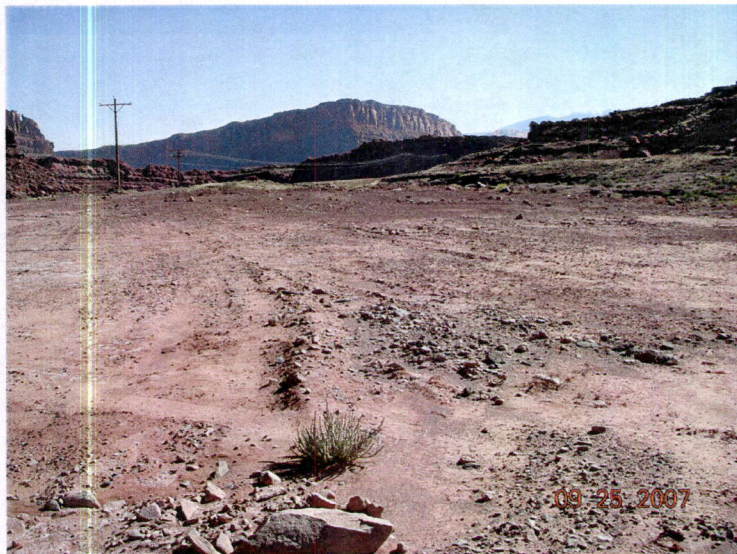
3. Plots near the wells. Soils at both of these sites were affected by salts. The plot near well 4 was irrigated but not furrowed. I did not see any plants growing from the seeding, but I did find one plant of Castle Valley clover. There were very few weeds. The other plot was ridged, and although there were not a lot of desirable plants, we did find Castle Valley clover and sand dropseed. There was a lot of halogeton and Russian thistle with lesser amounts of malcomia and cheatgrass. In these plots, it did appear that salt had concentrated on the furrow peaks as intended. Some of the soil (sand) washed into the furrows.

Photo 6. The plot by well 4.

Furrows seem to positively affect the amount of vegetation on salt-affected soils, and I suggest the operator consider furrowing and re-planting the plot near well 4.

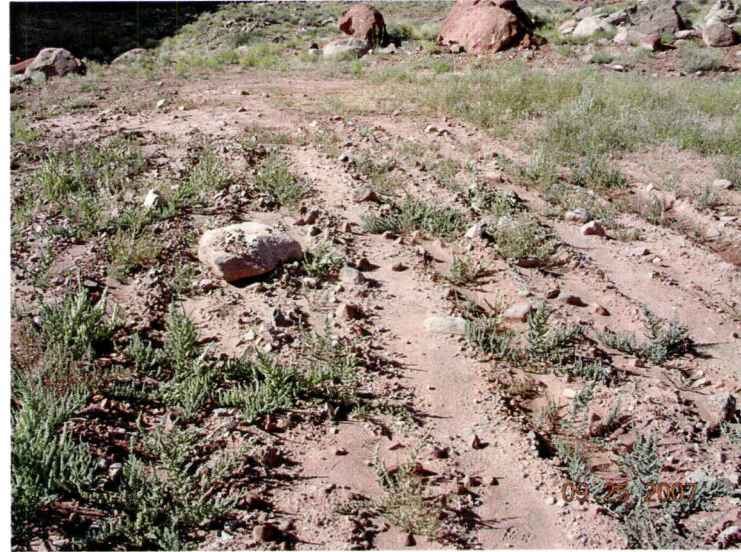
Photo 7. The plot by another well. The soil was furrowed, and most of the vegetation is halogeton.

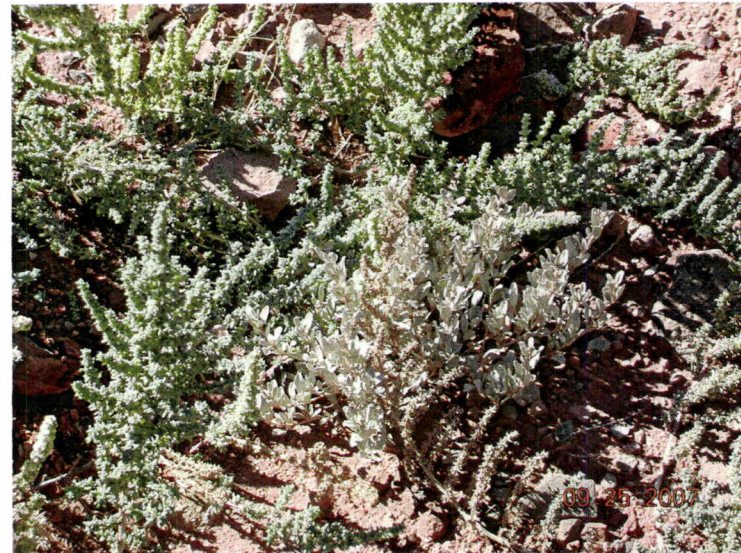
Photo 8. Castle Valley clover growing in the furrowed plot. There were a few, but not too many, desirable species.
